# Primary School Flood

**July 2020**

# Case Study 01

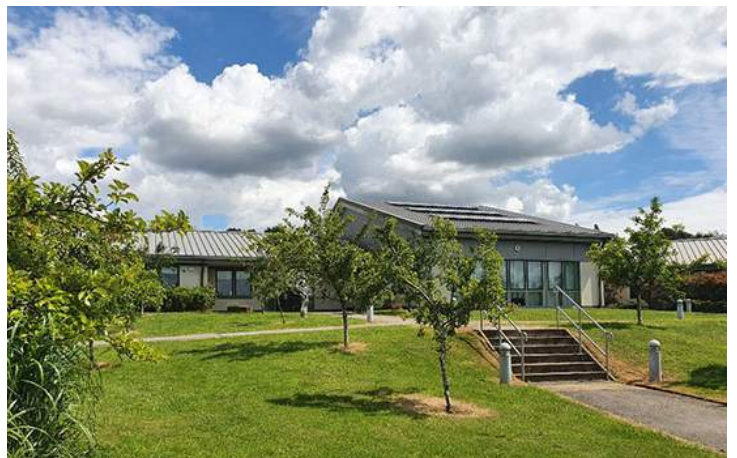
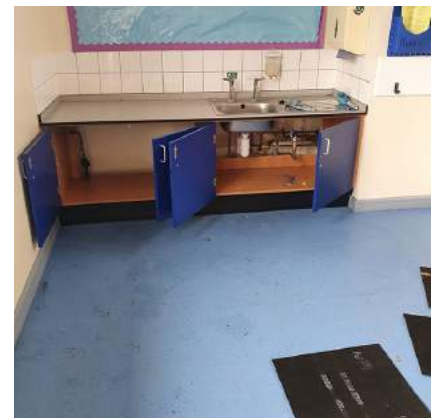
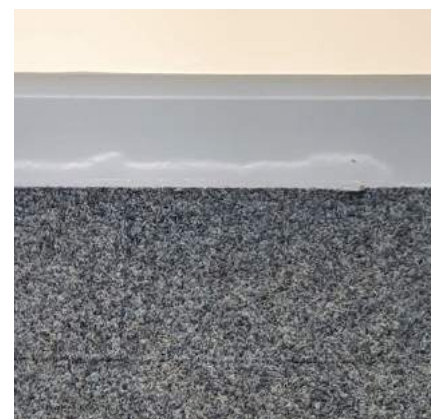
At this school there was a substantial leak from the pipe under sink unit to Classroom 6.

Water was escaping under mains pressure potentially over the whole weekend prior to being discovered by the Caretaker on Monday morning.

At this time, the escaping water was 3 inches deep within the Year 6 Classroom and had migrated into the adjoining cloakroom / toilet block and corridor. All floor coverings in these areas were saturated although teachers at the school had attempted to extract the water during the day.

MDF Skirting boards were showing signs of damage along with low level plasterboard to these areas.

We received the instructions at 11.40am and immediately deployed technicians to the site to undertake mitigation works arriving at 1.35pm.

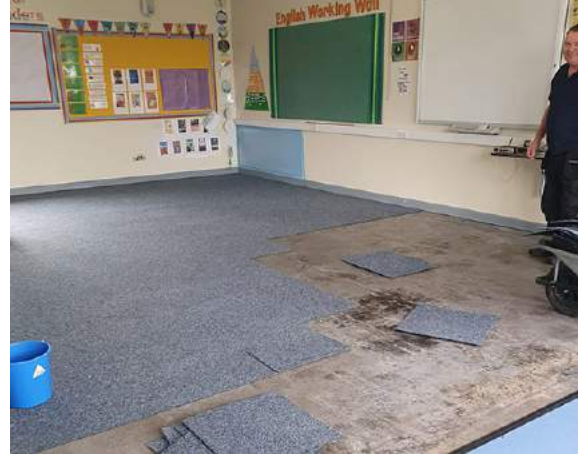
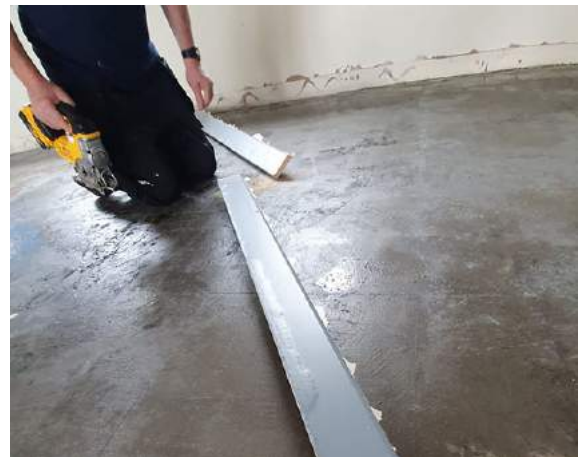
The concrete screed was drilled to the floor areas of the Year 6 Classroom, corridor and toilets, in order to establish if the water had migrated into the insulated cavity floor.

All readings taken indicated that the cavity was saturated and standing water was still present at this time, as evidenced in the attached photographs.

All polyprop carpet tiles were uplifted from Year 6 Classroom, along with floor coverings to part of the corridor, cloakroom and Altro non slip flooring from the Toilets / Disabled Toilets adjoining Year 6 Classroom.

MDF Skirting boards were removed from Year 6 Classroom, lying water extracted and affected areas sanitised prior to installation of mitigation drying equipment.

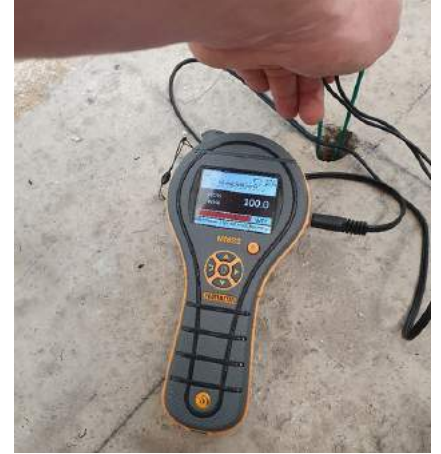
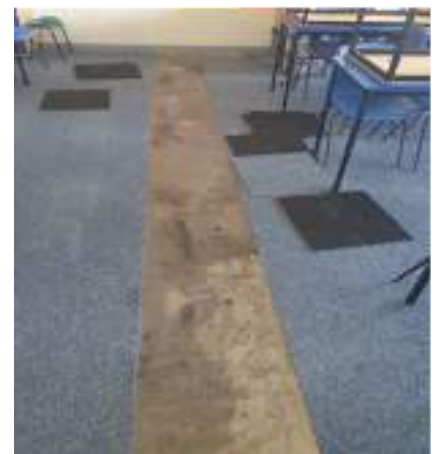
Following these works it became apparent that water had migrated into all four classrooms within this floor slab, along with associated cloakrooms, toilets and corridor with standing water seen when drilling through the screed.
