# Primary School Flood

**July 2020**

# Case Study 01

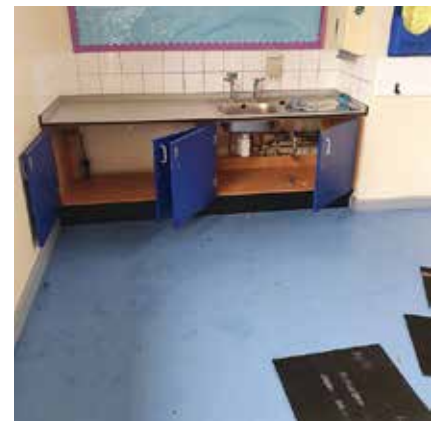
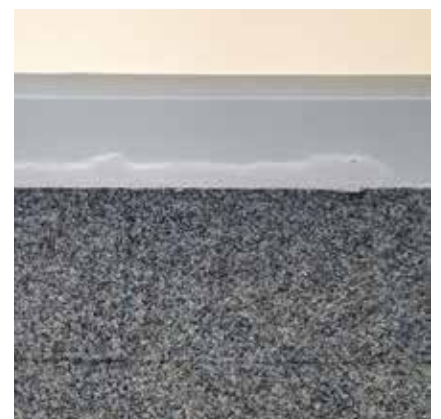
At this school there was a substantial leak from the pipe under sink unit to Classroom 6.

Water was escaping under mains pressure potentially over the whole weekend prior to being discovered by the Caretaker on Monday morning.

At this time, the escaping water was 3 inches deep within the Year 6 Classroom and had migrated into the adjoining cloakroom / toilet block and corridor. All floor coverings in these areas were saturated although teachers at the school had attempted to extract the water during the day.

MDF Skirting boards were showing signs of damage along with low level plasterboard to these areas.

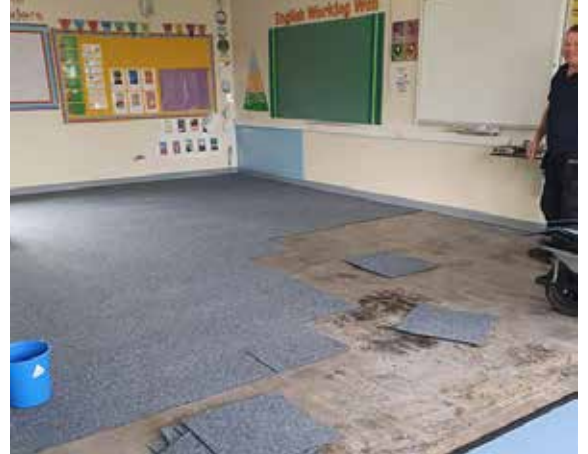
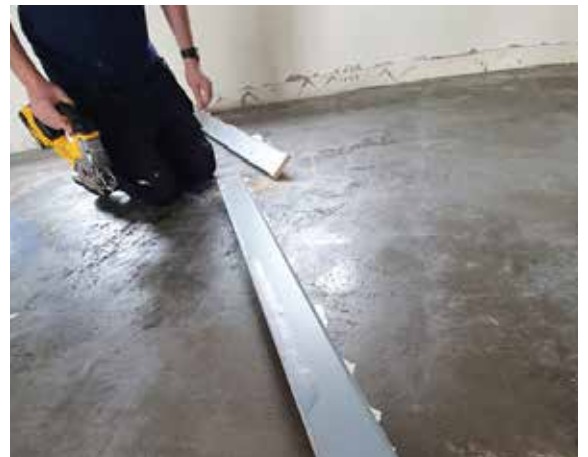
The concrete screed was drilled to the floor areas of the Year 6 Classroom, corridor and toilets, in order to establish if the water had migrated into the insulated cavity floor.

All readings taken indicated that the cavity was saturated and standing water was still present at this time, as evidenced in the attached photographs.

All polyprop carpet tiles were uplifted from Year 6 Classroom, along with floor coverings to part of the corridor, cloakroom and Altro non slip flooring from the Toilets / Disabled Toilets adjoining Year 6 Classroom.

MDF Skirting boards were removed from Year 6 Classroom, lying water extracted and affected areas sanitised prior to installation of mitigation drying equipment.

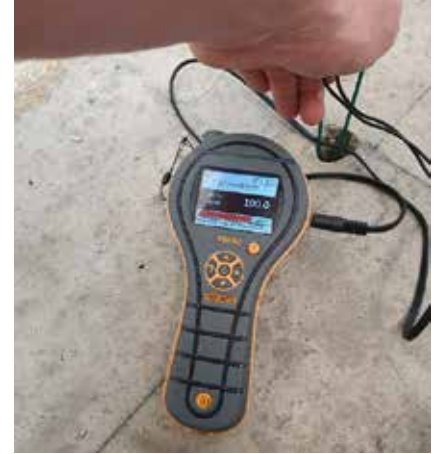
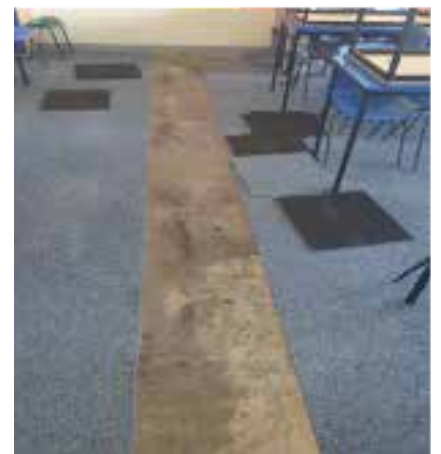
Following these works it became apparent that water had migrated into all four classrooms within this floor slab, along with associated cloakrooms, toilets and corridor with standing water seen when drilling through the screed.
