# Primary School Flood

**At this school there was a substantial leak from the pipe under sink unit to Classroom 6.**

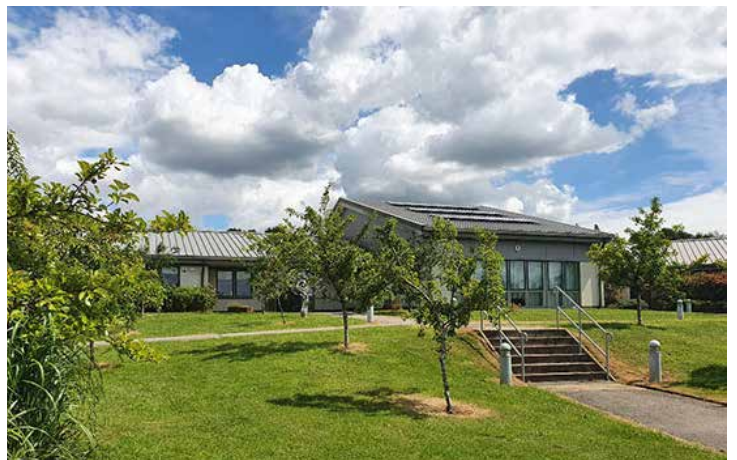
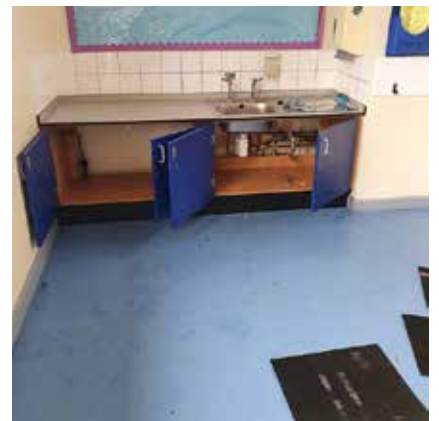
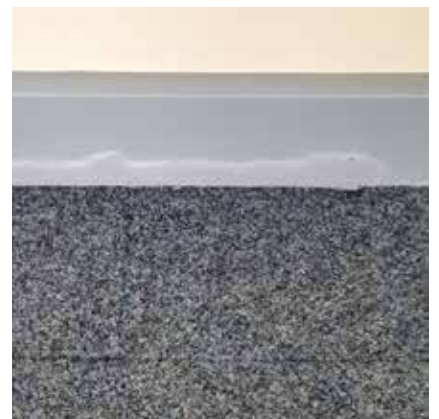
Water was escaping under mains pressure potentially over the whole weekend prior to being discovered by the Caretaker on Monday morning.

At this time, the escaping water was 3 inches deep within the Year 6 Classroom and had migrated into the adjoining cloakroom / toilet block and corridor. All floor coverings in these areas were saturated although teachers at the school had attempted to extract the water during the day.

MDF Skirting boards were showing signs of damage along with low level plasterboard to these areas.

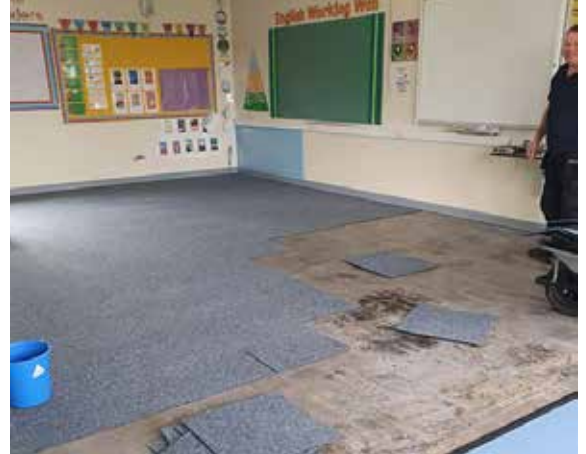
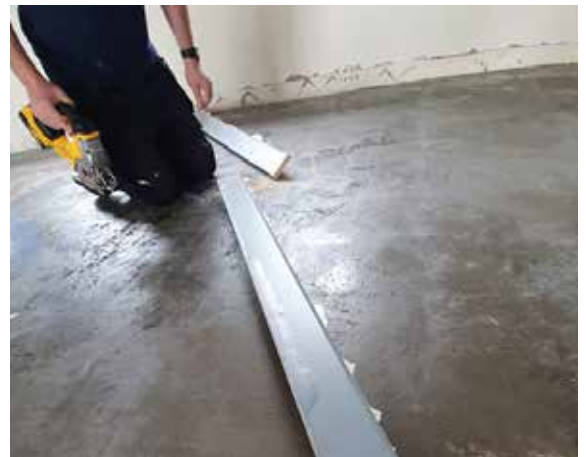
The concrete screed was drilled to the floor areas of the Year 6 Classroom, corridor and toilets, in order to establish if the water had migrated into the insulated cavity floor.

All readings taken indicated that the cavity was saturated and standing water was still present at this time, as evidenced in the attached photographs.

All polyprop carpet tiles were uplifted from Year 6 Classroom, along with floor coverings to part of the corridor, cloakroom and Altro non slip flooring from the Toilets / Disabled Toilets adjoining Year 6 Classroom.

MDF Skirting boards were removed from Year 6 Classroom, lying water extracted and affected areas sanitised prior to installation of mitigation drying equipment.

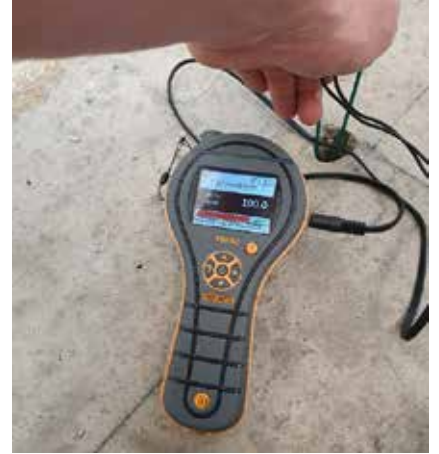
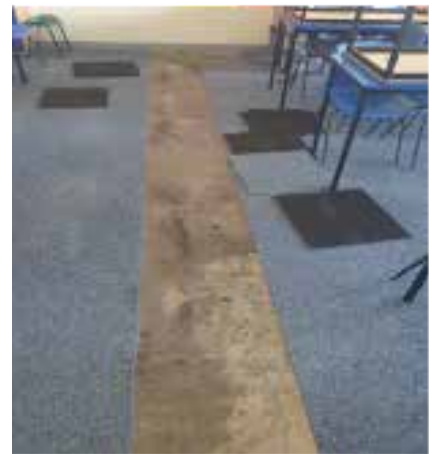
Following these works it became apparent that water had migrated into all four classrooms within this floor slab, along with associated cloakrooms, toilets and corridor with standing water seen when drilling through the screed.
