# Speed Drying to Domestic Property on the Market

# Case Study

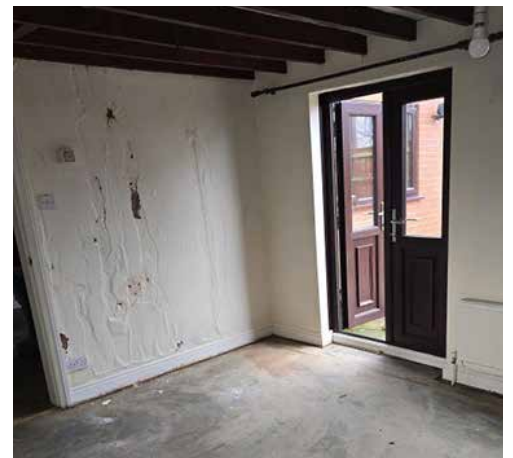
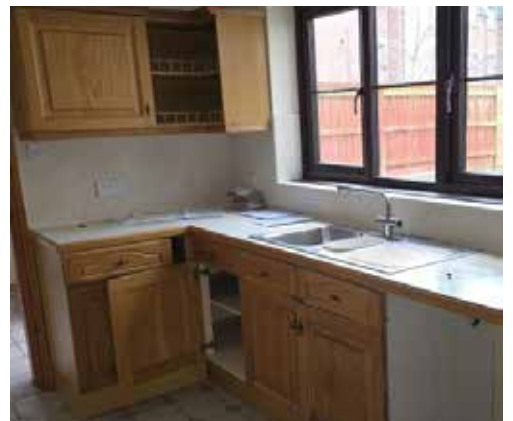
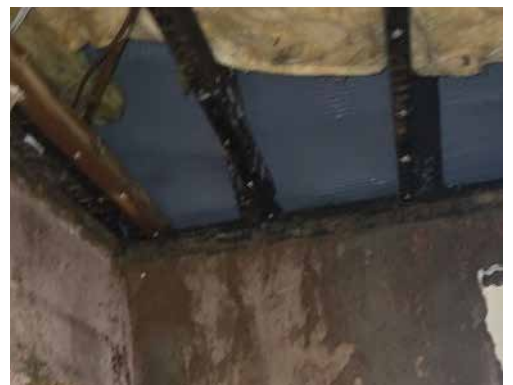
**During a period of extreme cold in January 2026, a significant burst pipe occurred at an unoccupied four-bedroom detached property that was actively on the market.**

Water escaped under full mains pressure for approximately three weeks before the issue was discovered, allowing moisture to spread both vertically and horizontally throughout the building.

Upon inspection, all internal surfaces were found to be heavily saturated, with elevated moisture readings recorded across all areas of the property.

Complicating matters further, the boiler had been condemned as a result of the incident, meaning that low internal temperatures also had to be factored into the drying strategy.

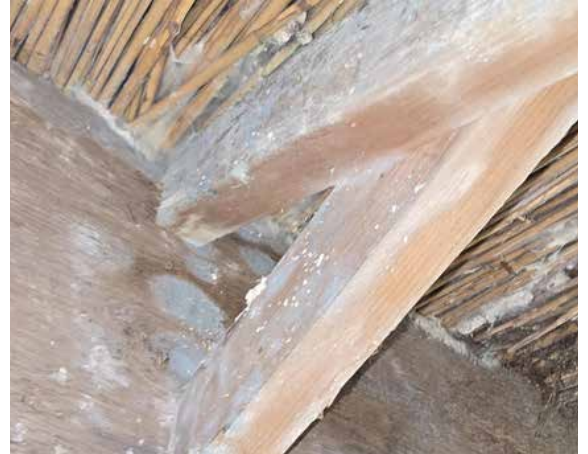
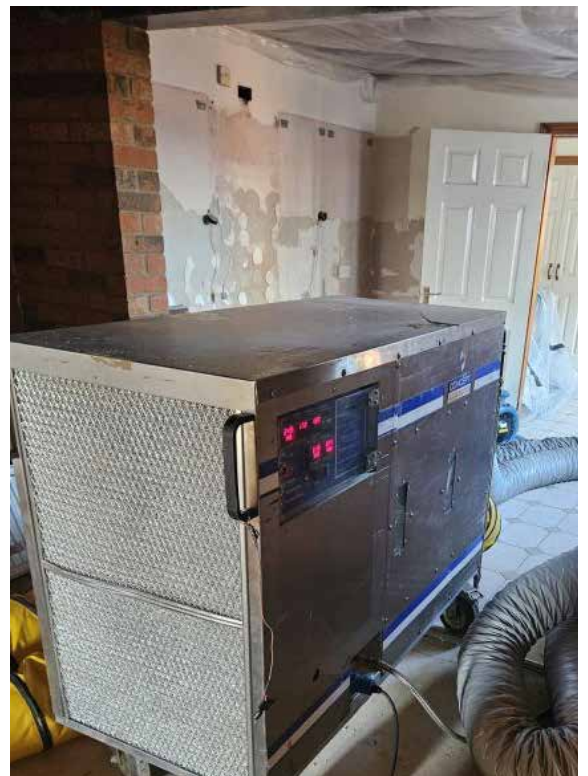
A significant and hazardous mould outbreak was also present, this was remediated under controlled conditions and post treatment samples were taken to evidence the air and surfaces were free of contaminant.

Following strip-out works, we recommended a speed-drying approach using the ADS3000 system.

As a result, following stripping out works, the property was successfully dried within just nine days, allowing the sale process to continue with minimal delay.
